Date Released: February 24, 2016

Subject: ALTA ESC Firmware Update Version 1.0.1

Affected ALTAs: All ALTAs shipped prior to February 11, 2016

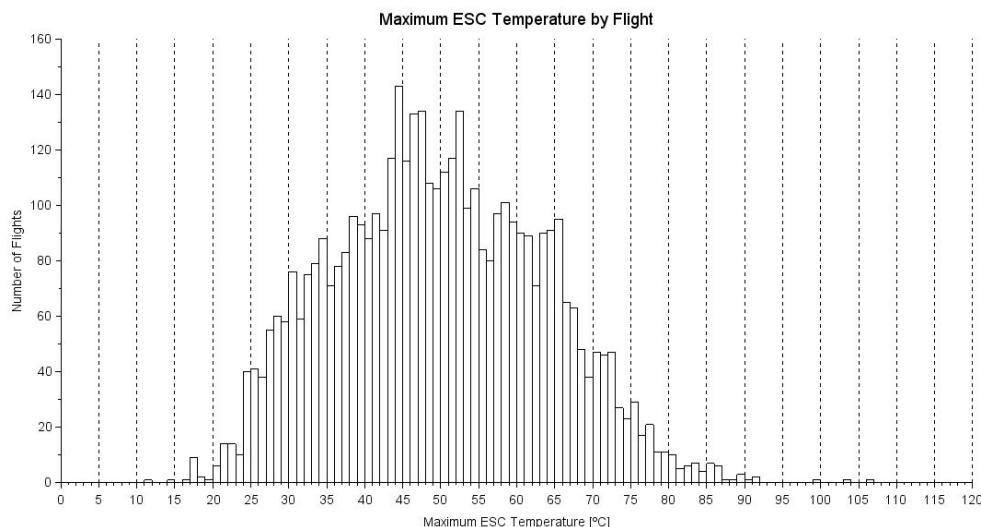
This high-temperature fault is most likely to be provoked when flying at a gross weight above the limitations stated in the ALTA AFM, though it may be possible to reach this limit even if gross weight does not exceed specifications. A review of available flight data from over 4400 ALTA flights across a range of operating conditions shows that most flights will remain below 70°C. Operating payload, flight style (aggressive vs. docile), and ambient temperature can affect individual results.

Figure 1. Review of available flight data from 4400 ALTA flights.

The best way to determine whether or not to perform the ESC firmware update is to review your previous flight data and assess your typical operating style and conditions. The ALTA records flight data on a microSD card accessible from the GPS/Compass mount. Answering these questions can help make an informed decision:
